MTMC REPORT OA 77-2

**ANALYSIS  
OF MTMC PARTICIPATION  
IN THE  
REFORGER 77 EXERCISE**

FEBRUARY 1978

**MILITARY TRAFFIC MANAGEMENT COMMAND  
TRANSPORTATION ENGINEERING AGENCY  
NEWPORT NEWS, VIRGINIA 23606**

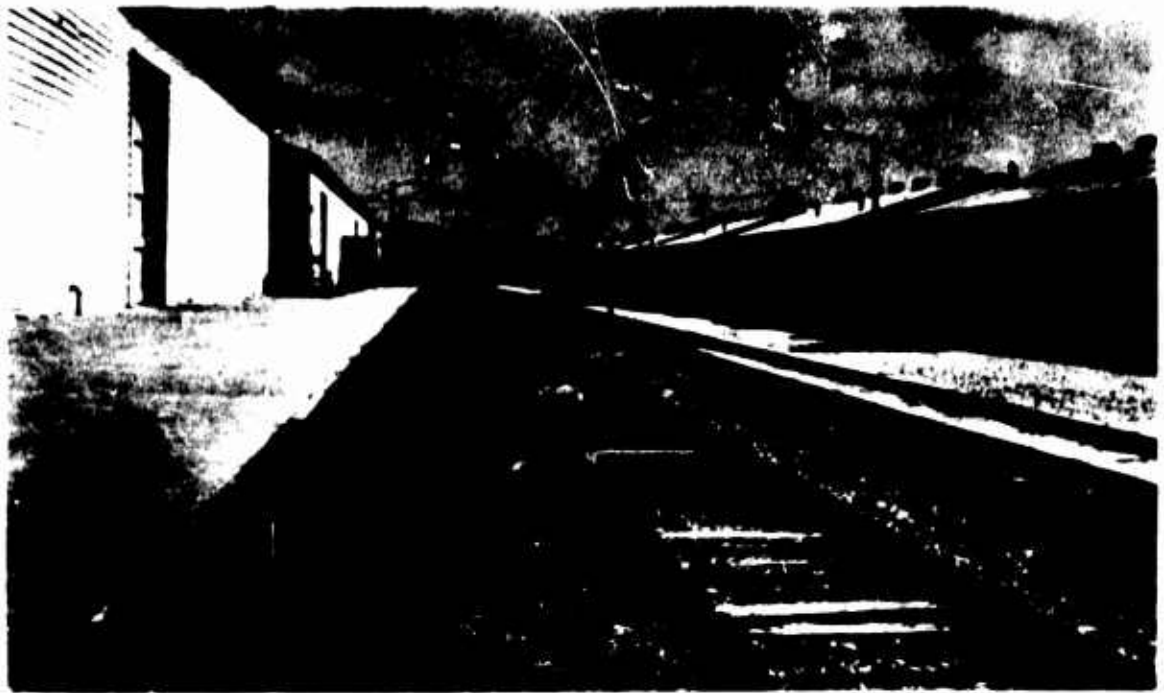
Figure 6-4. Camp Whiteside area.

(2) The Camp Whitside area (fig 6-4) has four rail spurs positioned between a double row of warehouse buildings with side-loading ramps. The area is suitable for loading general cargo, containers, and CONEXs; however, there is insufficient staging area for a large number of vehicles and trailers. Fifty railcars could be spotted in this area for loading or storage. The Camp Funston area (figs 6-5 and 6-6) has two main rail spurs, with eight loading points. This area is well suited for roll-on loading of railcars. Adequate staging areas and permanent end-loading ramps are available.

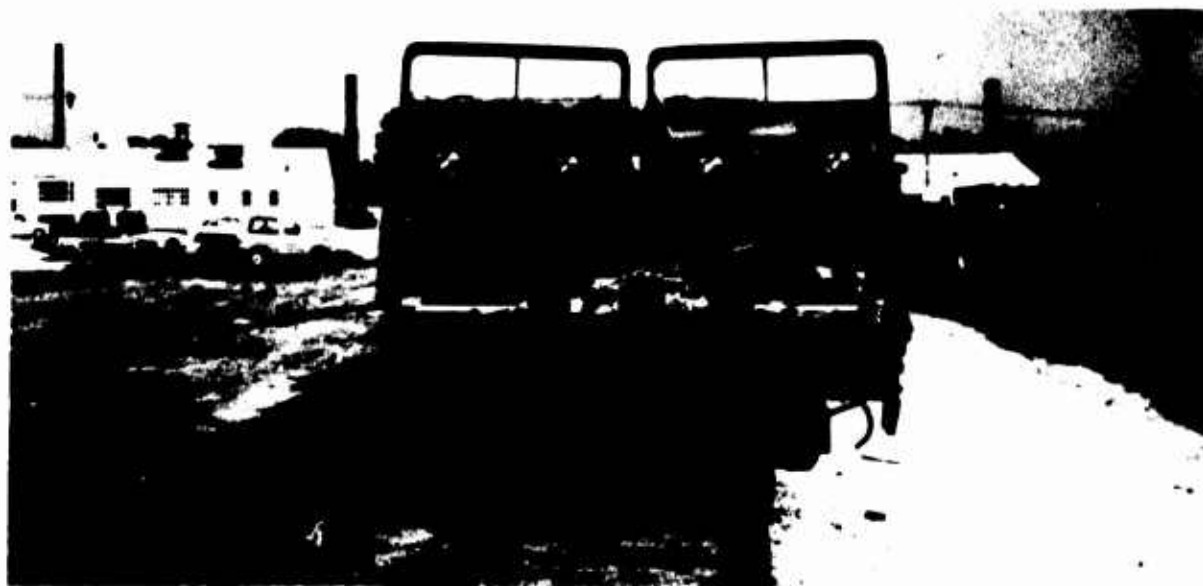
Figure 6-12. 1/4-ton trucks loaded abreast.

(e) 1/4-ton trucks loaded abreast were not wired together and did not have 2- by 4-inch (5- by 10-centimeter) pieces of lumber placed between the adjacent wheels to prevent chafing (fig 6-12).

(3) MTMC representatives advised the loading teams to correct loading rule violations whenever they were noted. In addition, the following suggestions were offered but not accepted.

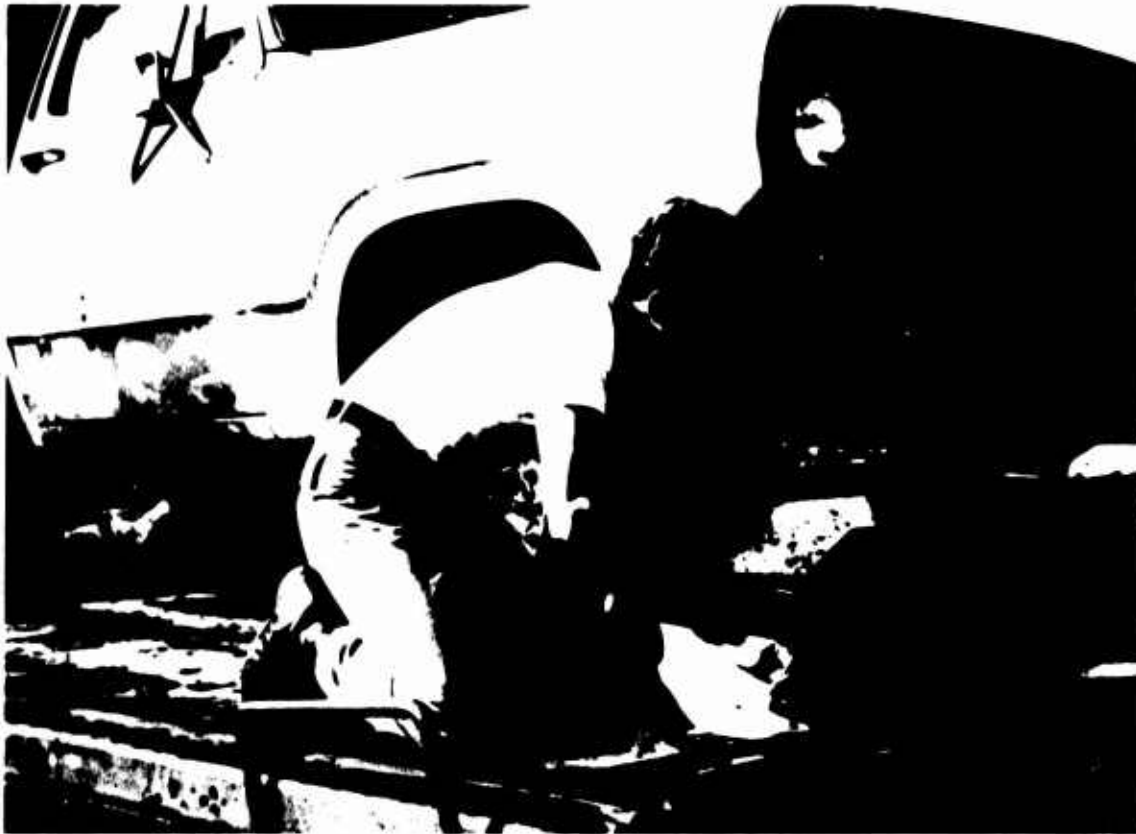
Figure 6-13. Chocking and bracing being applied on a chain tiedown flatcar.

(a) A recent change in the AAR loading rules eliminates the need for chocking and bracing on chain tiedown cars. The division elected, however, to chock and brace their equipment in addition to using the chain tiedown (fig 6-13).

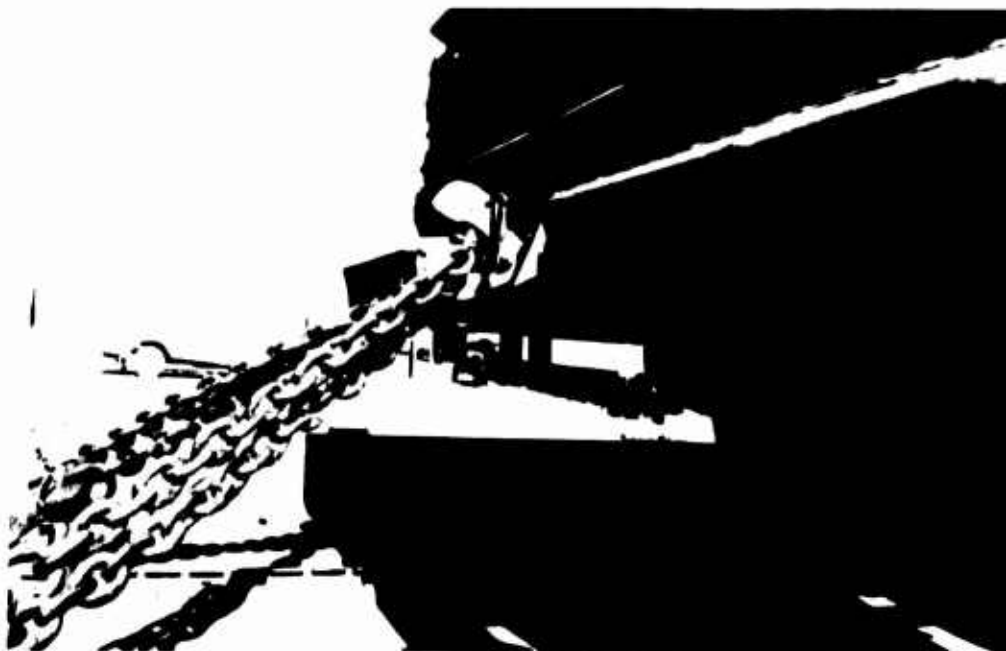
Figure 6-20. Rear tiedown on M-880 pintle.

(1) The loading of the cars for the first train was slow and inefficient. Misapplication of chains, wire rope, and blocking and bracing materials was apparent at all loading sites (figs 6-20 through 6-22).

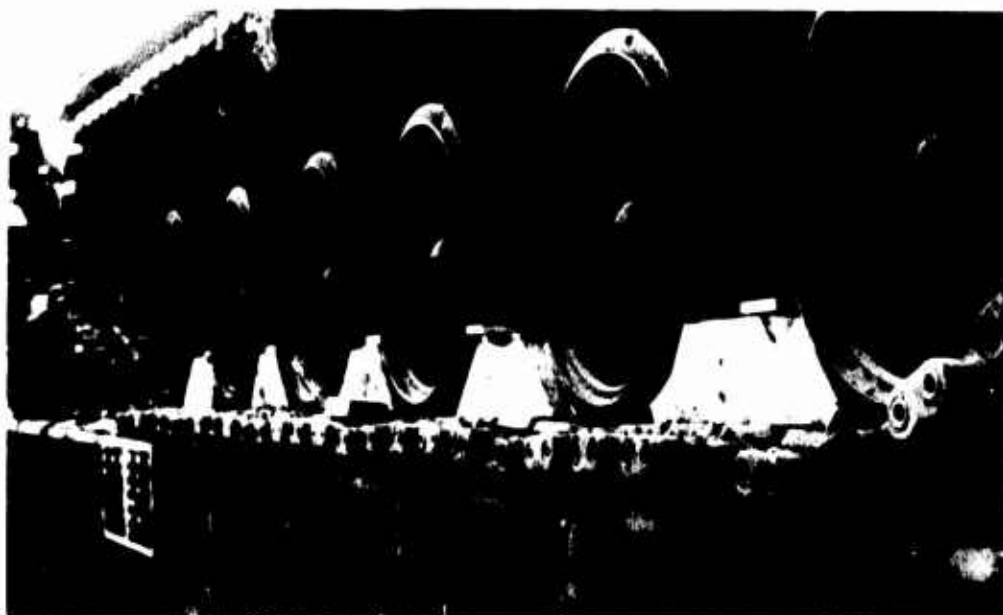
Figure 6-21. Improper M-60 road wheel chocking.

(7) Although MTMC personnel at Fort Carson pointed out specific errors in loading procedures (that is, improper banding of trailers, incorrect application of tiedown devices, and so forth), the errors were corrected only if the servicing railroad also agreed. The attitude of the Fort Carson personnel was simply that if the servicing railroad accepted the train, further corrections were not necessary. AAR loading rules should be uniformly applied.

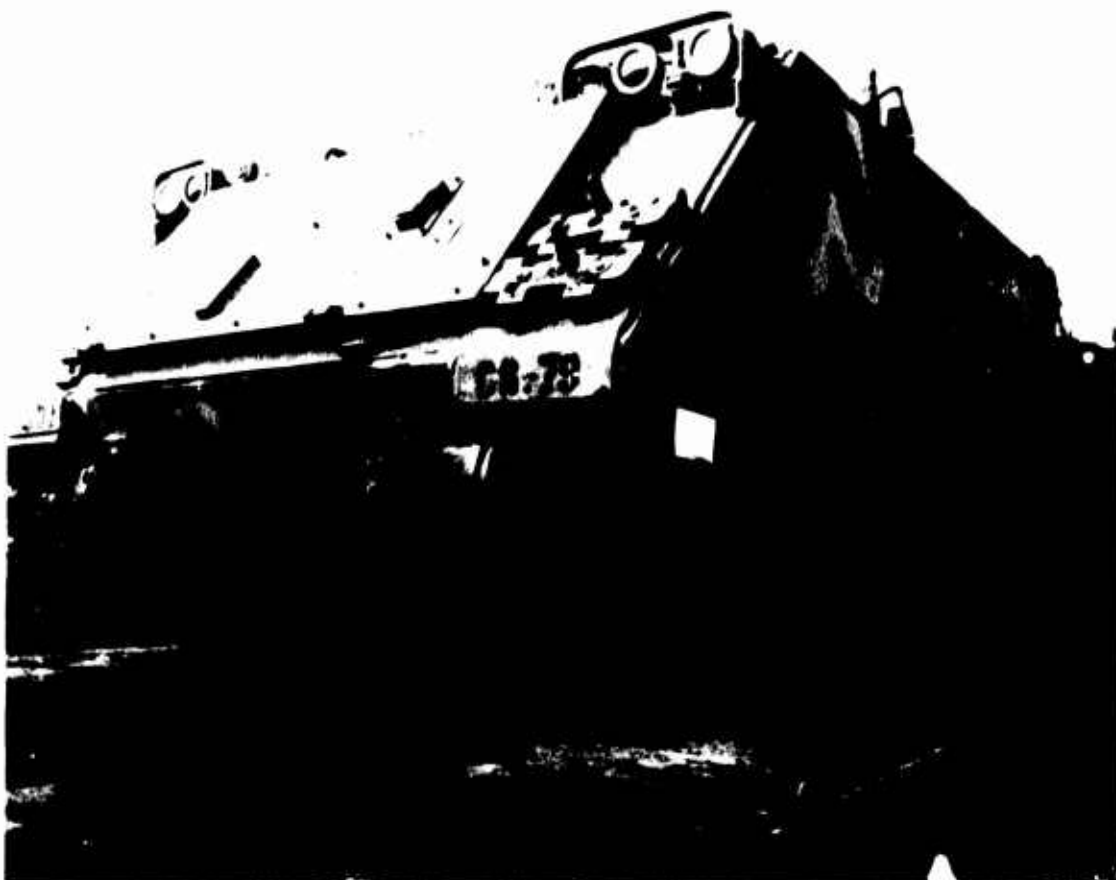
(2) Practices and standards prescribed by the AAR, the servicing railroad, and Fort Carson were not consistently applied, causing duplication and confusion in the loading and tiedown of equipment (figs 6-23 through 6-25).

Figure 6-24. M-113 excess tiedown.

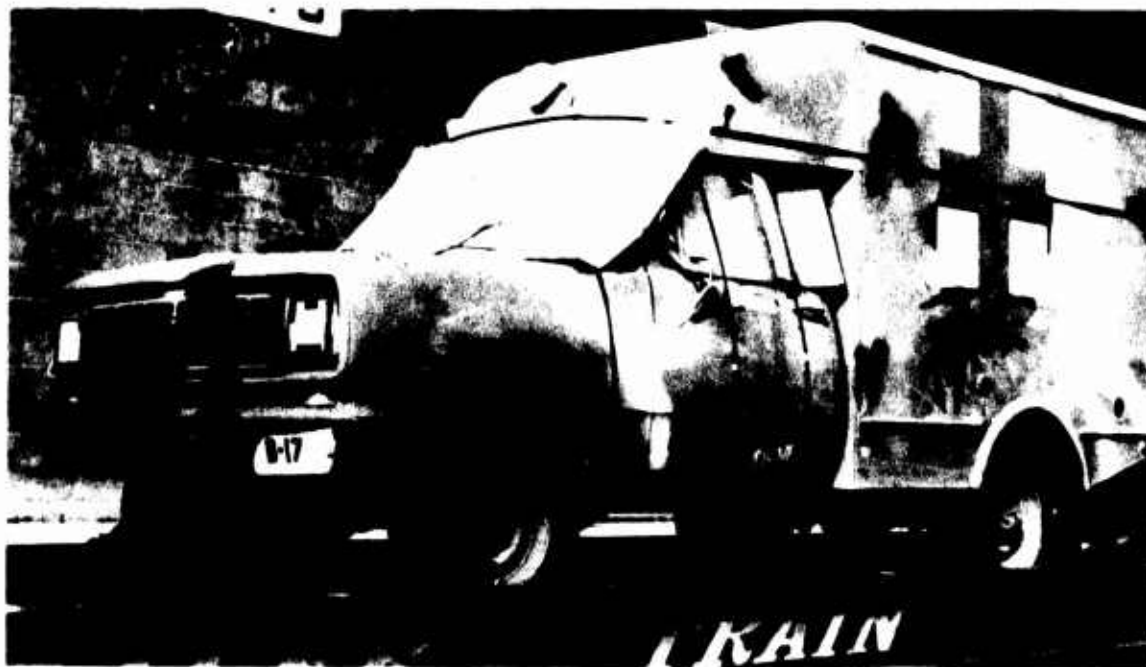
(5) Vehicles in most cases were overprotected. Taping and padding of headlights, boxing of windshields, and other overprotective measures were unnecessary (figs 6-26 through 6-28). (AR 220-10 and FORSCOM Reg 55-1.)

Figure 6-26. M-886 windows and headlights protected.

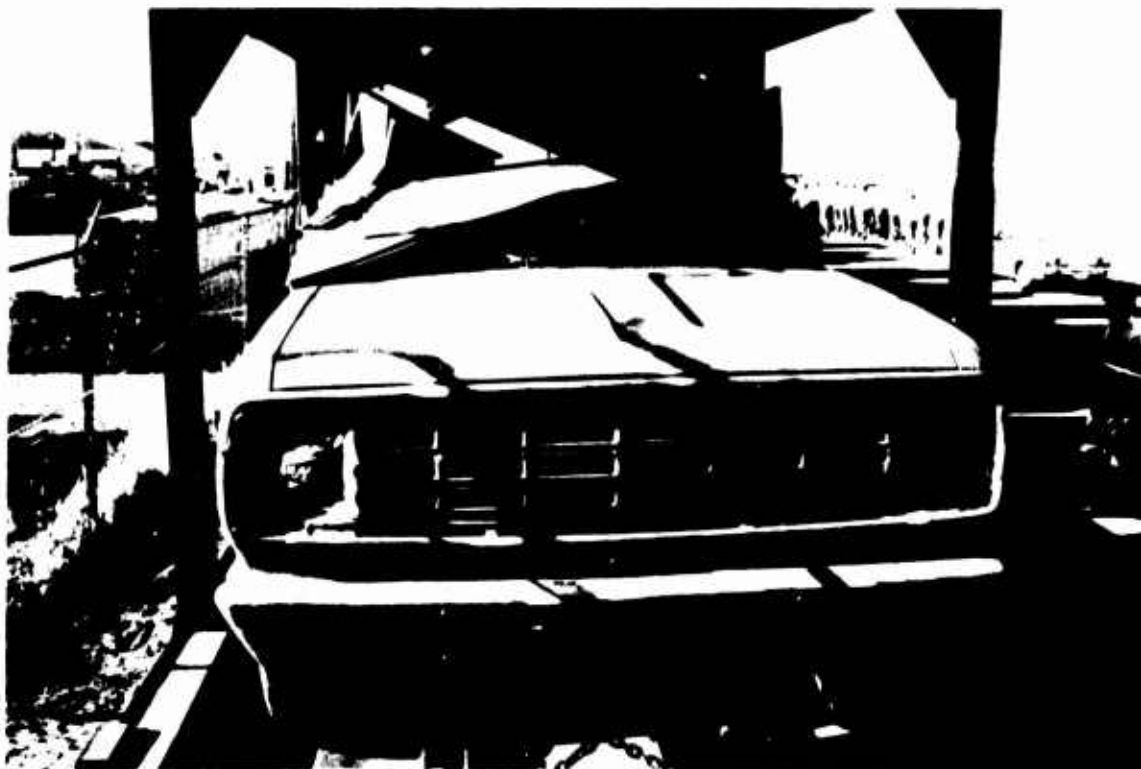
Figure 6-27. M-880 windshield and headlights protected.

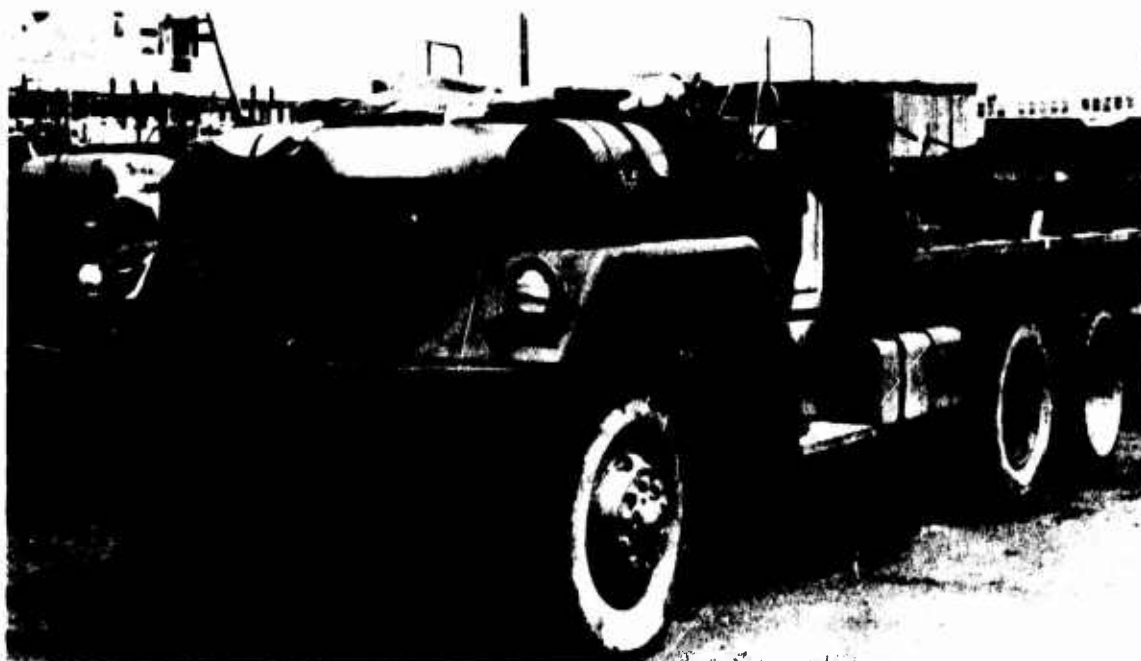
Figure 6-28. M-813 windshield and headlights protected.

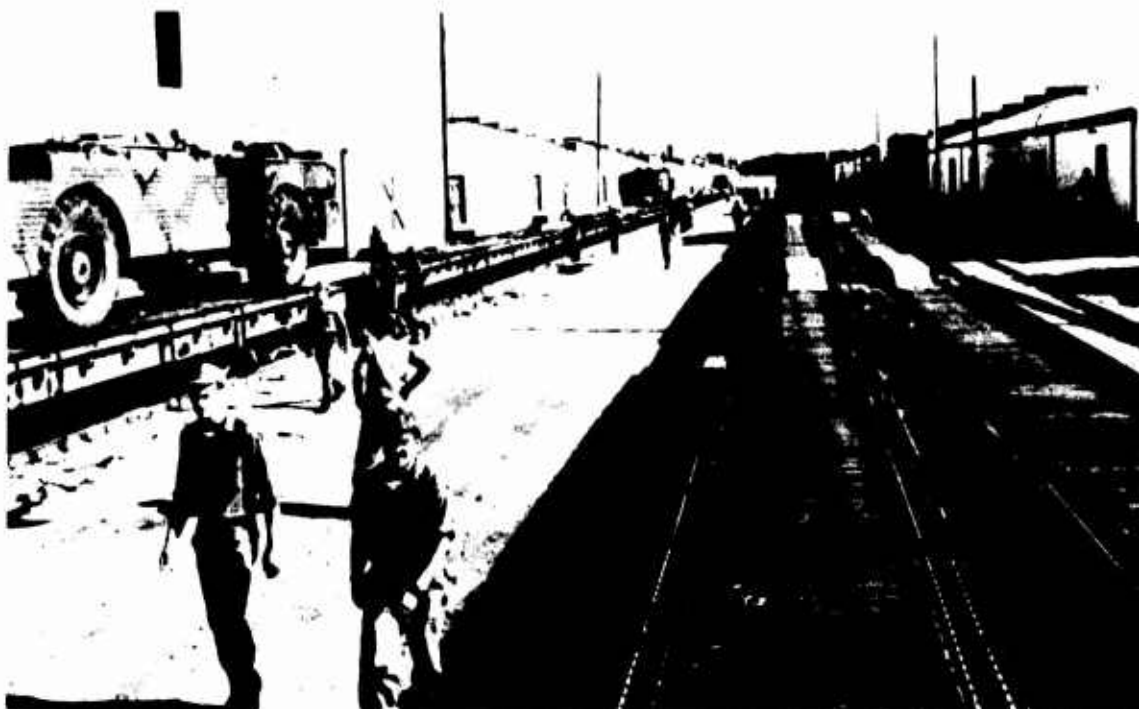
a. The railcars furnished by the ATSF were in excellent condition. Many were new (fig 6-29).

Figure 6-29. Railcar condition.

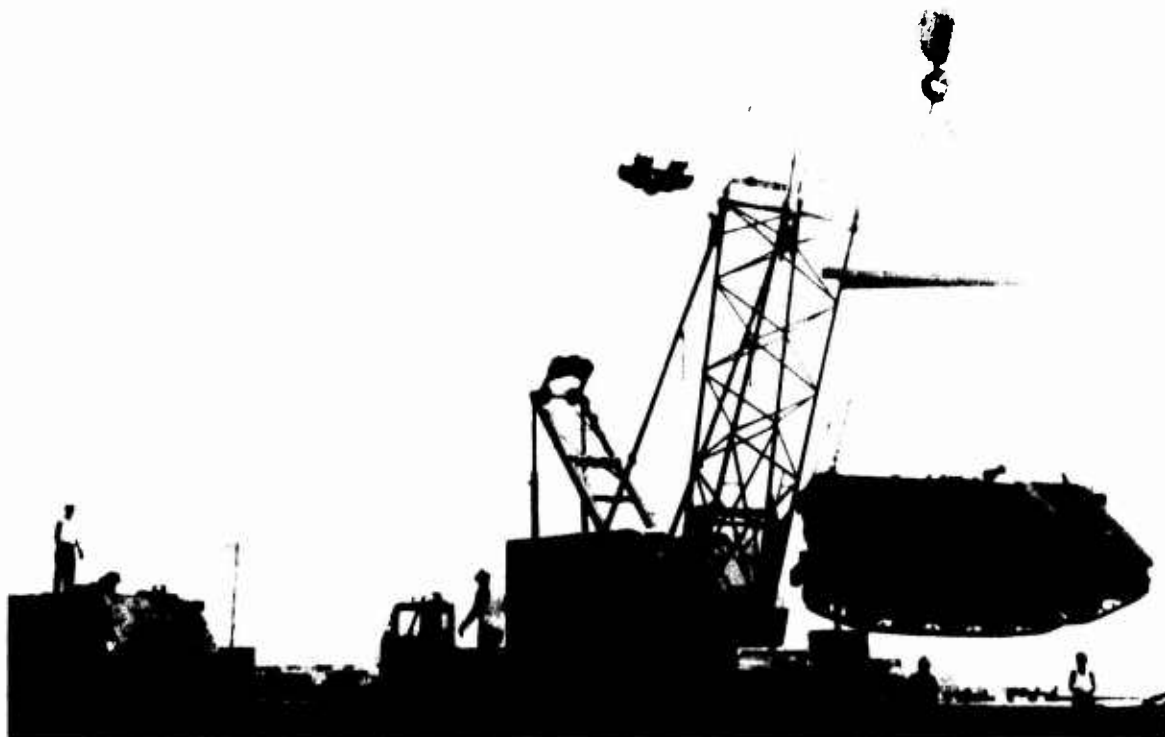
Figure 8-4. M-113 rail offload.

(1) All tracked vehicles were lifted off railcars using a mobile crane (figs 8-4 and 8-5). The lift-off operation, which is significantly slower than a drive-off operation, was required because a reinforced end-loading ramp capable of supporting the M-60 and M-88 was not available.

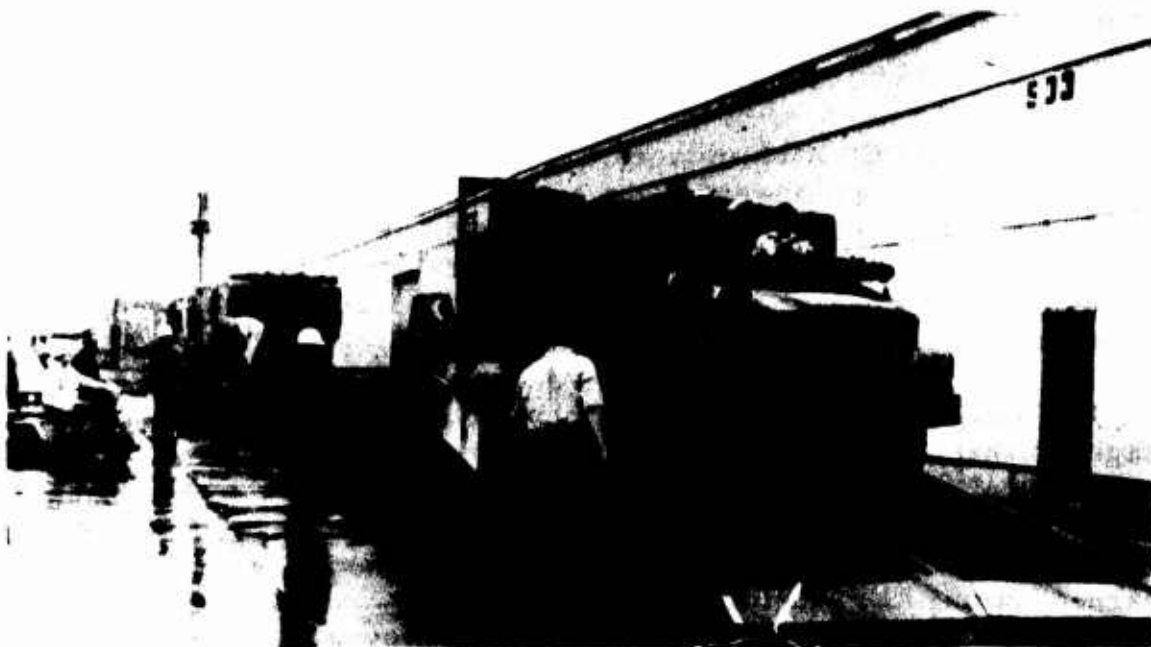
Figure 8-7. Vehicular drive-off

(3) Wheeled vehicles were driven off the flatcars using a portable end ramp and, in most cases, one railcar spanner which required forklift support (fig 8-7); however, additional railcar spanners were available.

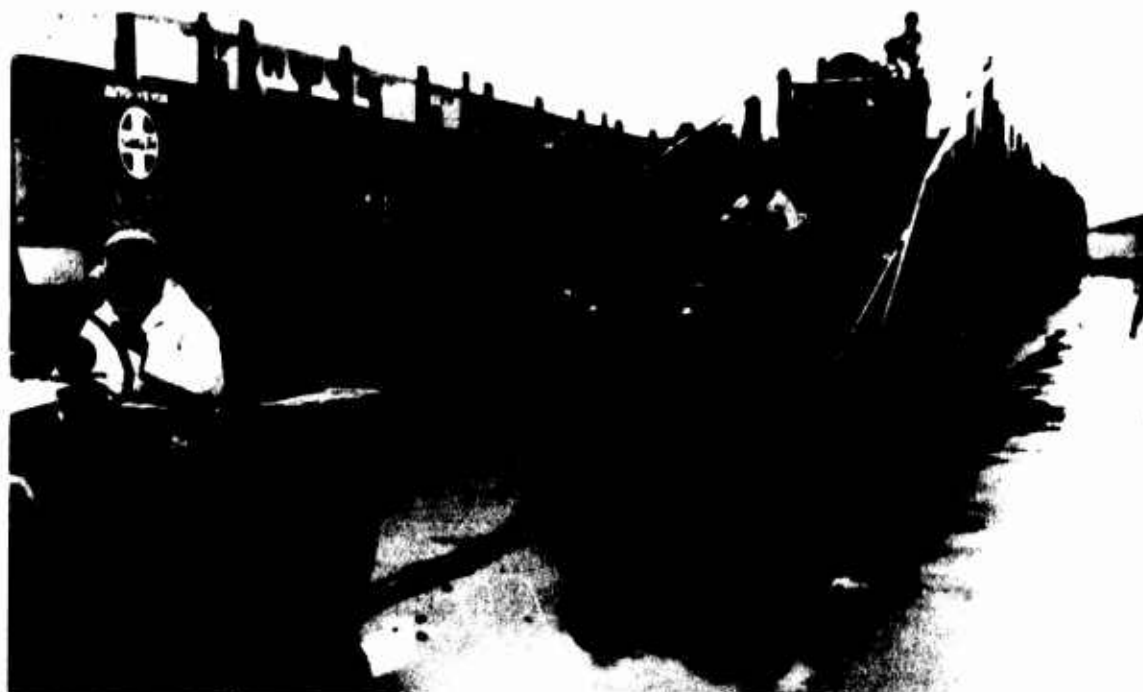
Figure 8-8. Bilevel drive-off.

(4) The vehicles loaded on 89-foot bilevel railcars were off-loaded using a specially designed end ramp (fig 8-8). Due to a restrictive curve at the approach to the USNS Comet staging area, the 89-foot bilevels were offloaded approximately one-half mile from the USNS Comet staging area and were lined up in a temporary holding area for subsequent movement to the staging area.

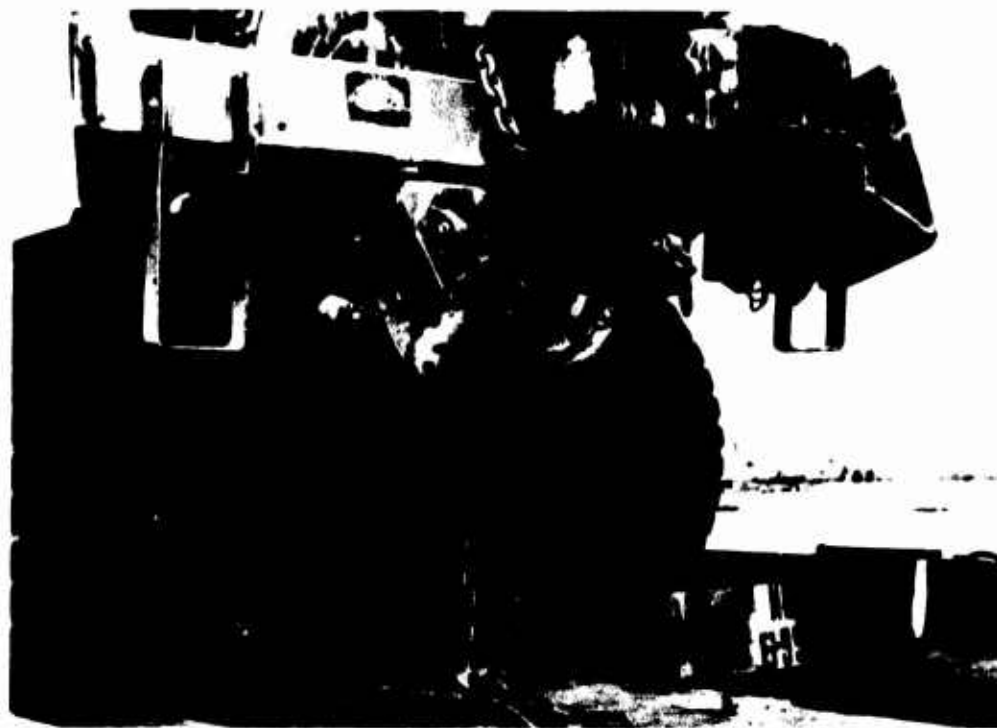
j. Damage to REFORGER cargo and equipment during movement, receipt at MOTBY, and staging was minimal. Damage consisted primarily of minor dents and scratches. A few vehicles arrived with the rear bumpers torn off due to improper tiedown procedures (fig 8-11). Six tanks arrived without gun tube travel locks; however, there was no apparent damage.

Figure 8-11. Improper tiedowns.

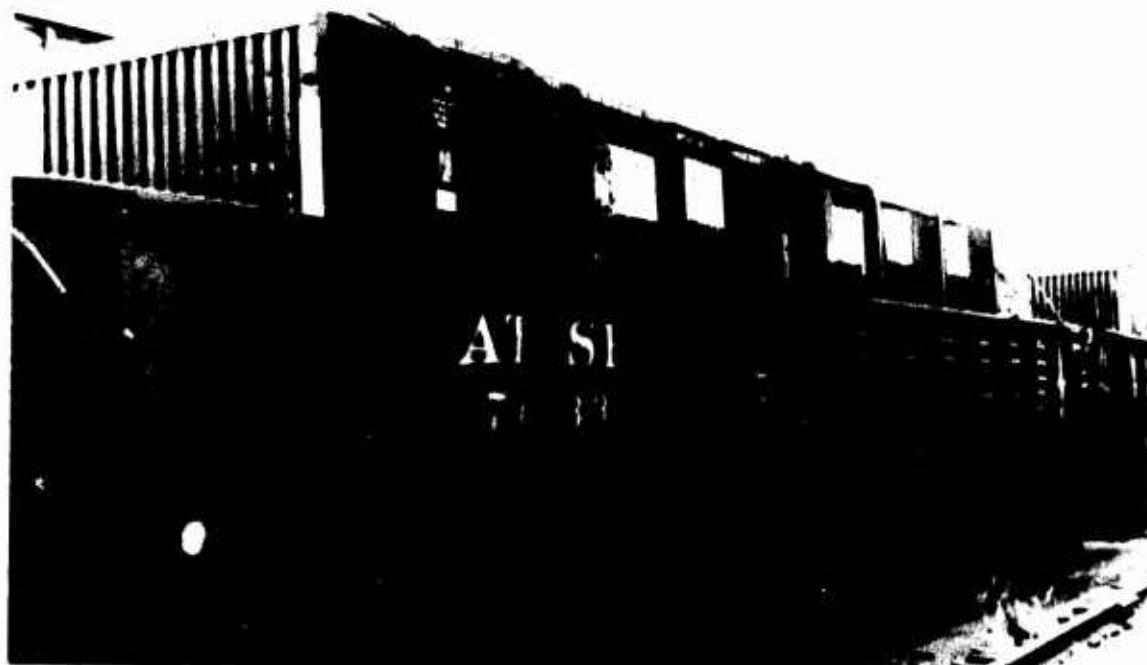
c. CONEXs were loaded six to a gondola railcar at Fort Carson. The CONEXs were tied down with number 8 gauge wire (twisted). This left an unbraced open space of approximately 6 feet (1.8 meters) between the last CONEX and a communications shelter loaded at the other end of the car. This lack of bracing caused the wire tiedowns to break and, in one case, the entire CONEX load to shift against the communications shelter (fig 8-12).

Figure 8-12. Broken wire tiedowns on gondolas.

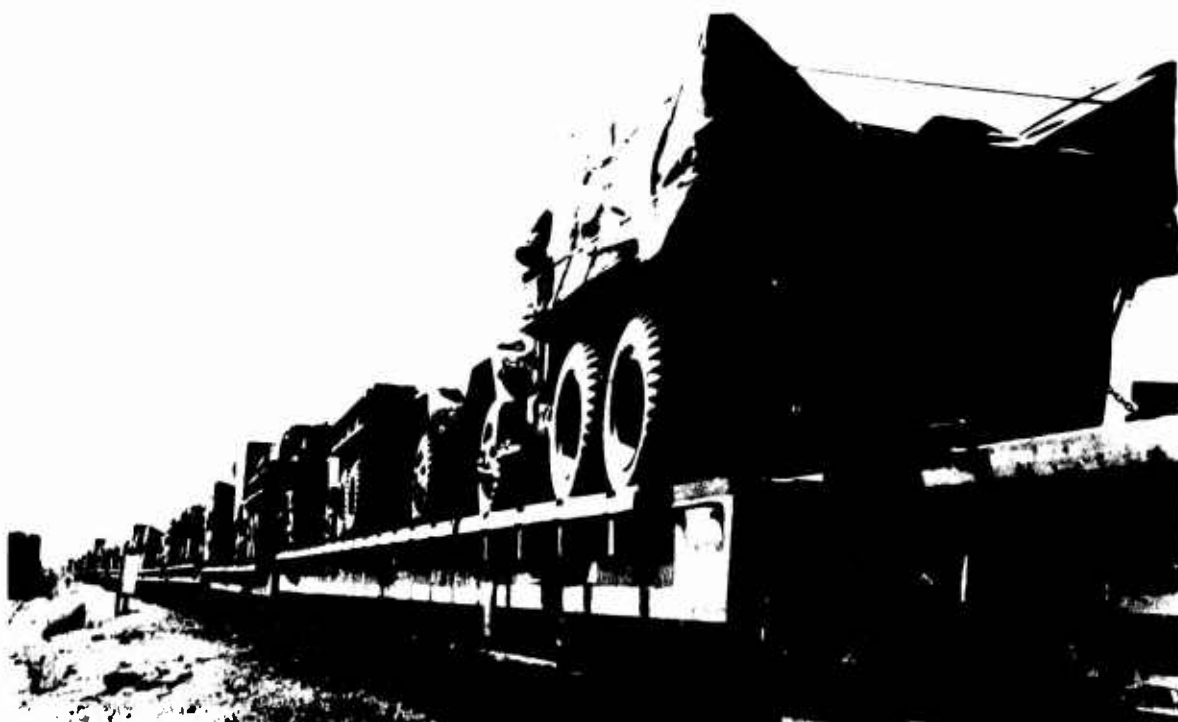
Figure 8-16. Improper height reduction.

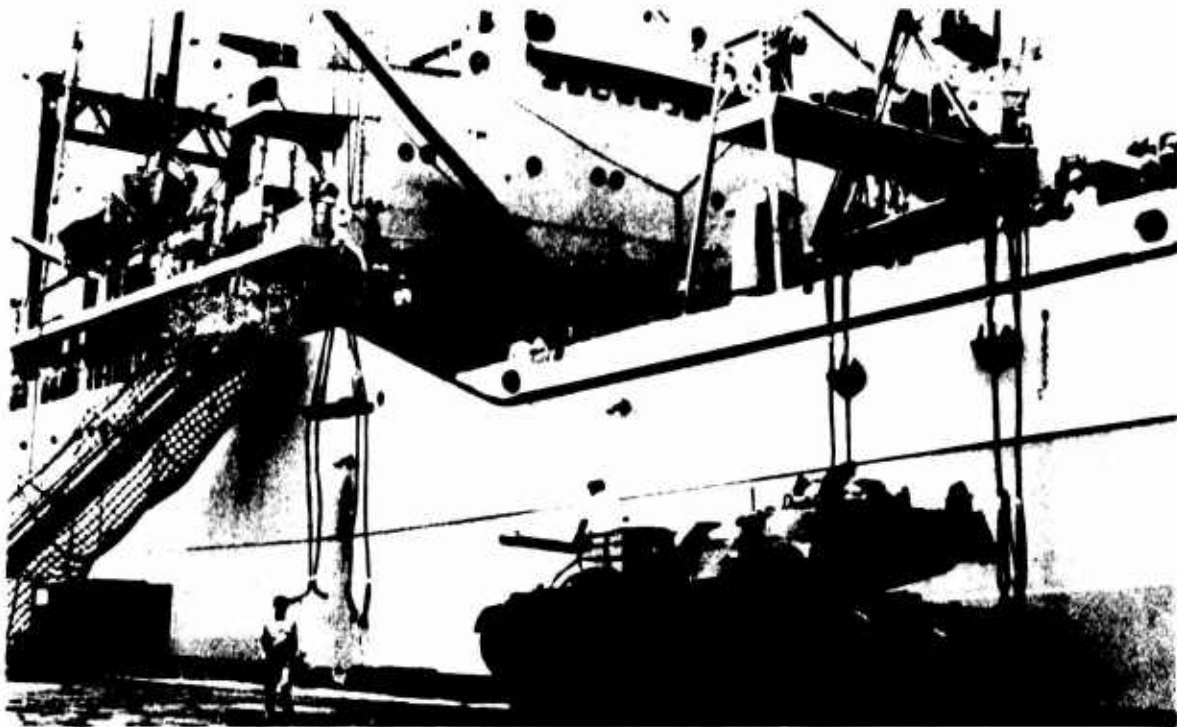
Figure 8-18. USNS Comet heavy lift.

(5) The jumbo boom on hatch number 3A overheated and was shut down prior to the last heavy lift on the forward main deck (fig 8-18), necessitating an adjustment to the stow (the last tank was placed on the starboard side aft main deck and an M-579 GOER was placed on the number 4A hatch cover).

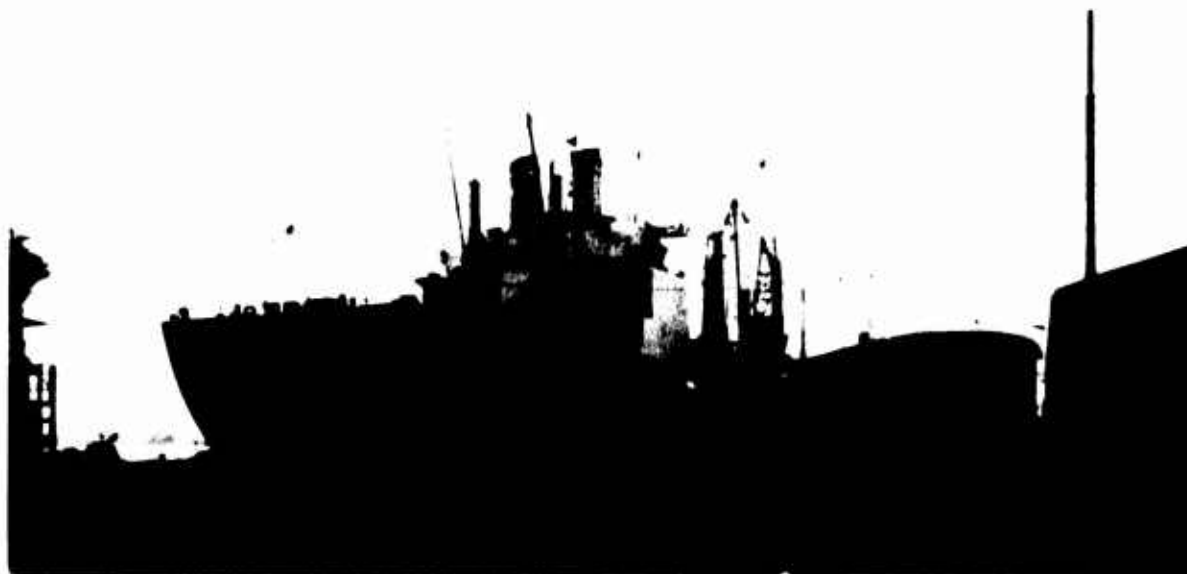
Figure 9-4. GTS Callaghan at Amsterdam RORO ramp.

a. The facilities used in the port of Amsterdam are shown in figure 9-3. The GTS Callaghan was berthed at 1724 hours, 31 August 1977, at the West Terminal's permanent RORO ramp (fig 9-4). Lashing gangs immediately started unlashng the equipment in order to expedite discharge operations commencing on 1 September 1977.

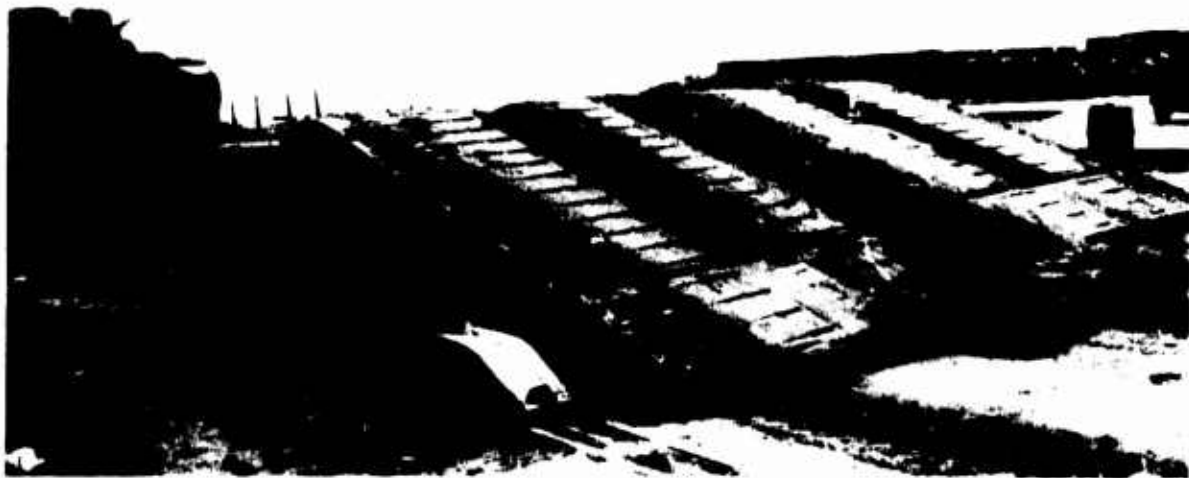
Figure 9-6. Rail loading ramp furnished by The Netherlands.

by The Netherlands Ministry of Defense (figs 9-6 and 9-7). These ramps rested on the end of the flatcar and attached to the rail track, thus preventing movement of the railcar during loading operations. When loading is completed, the ramp can be disassembled and shipped on a railcar underneath the tanks being moved. These ramps proved to be the most satisfactory method for loading tanks during REFORGER 77 operations.

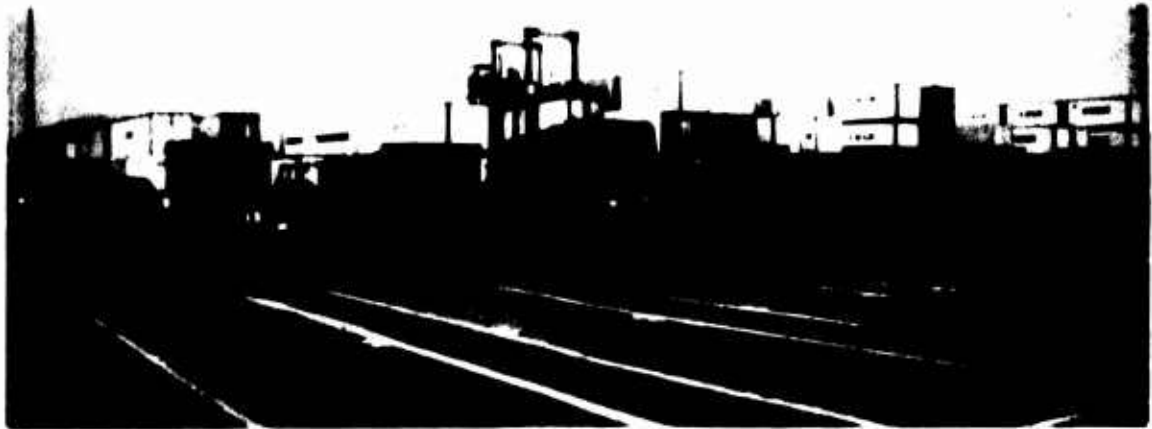
Figure 9-8. Roadable vehicles lined up for drive-away.

d. Convoyable wheeled vehicles with trailers were lined up in a temporary staging area in order of discharge from the ship (fig 9-8), for subsequent movement to Haarlem, The Netherlands, which was the designated convey assembly area, approximately 16 miles (25 kilometers) from the port.

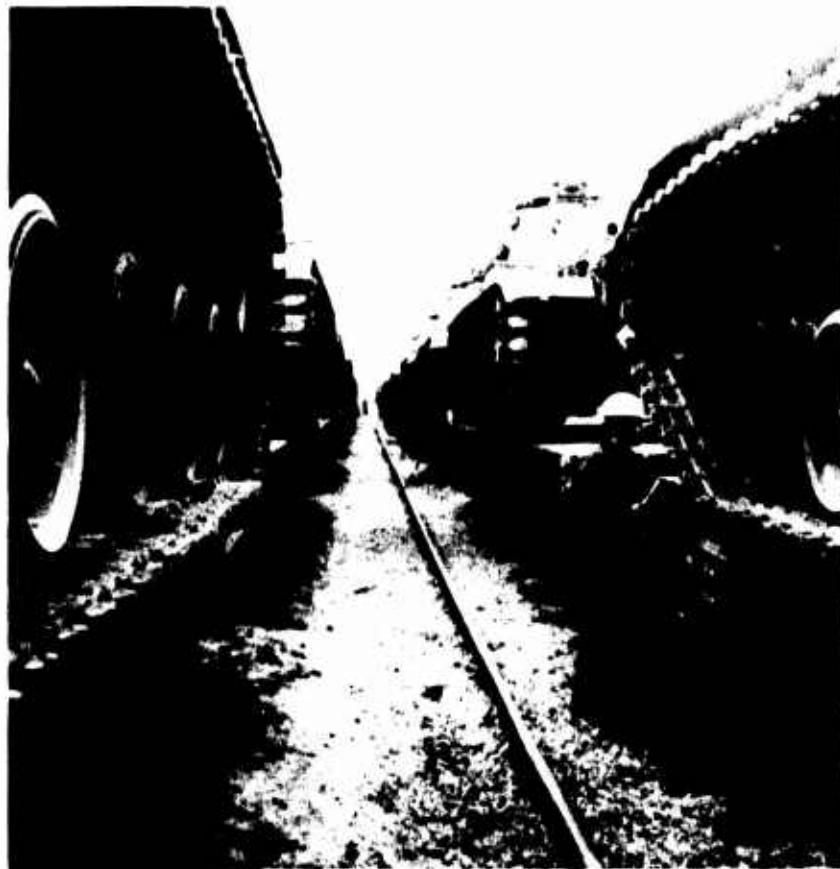
Figure 9-9. Tracked vehicles awaiting blocking and lashing.

f. Loaded railcars were secured at the loading site. After approval by The Netherlands Railway Inspector, groupings of 12 to 15 railcars were moved to a marshalling area 3/5-mile (1 kilometer) from the loading site (fig 9-9). This procedure accelerated the port clearance operation.

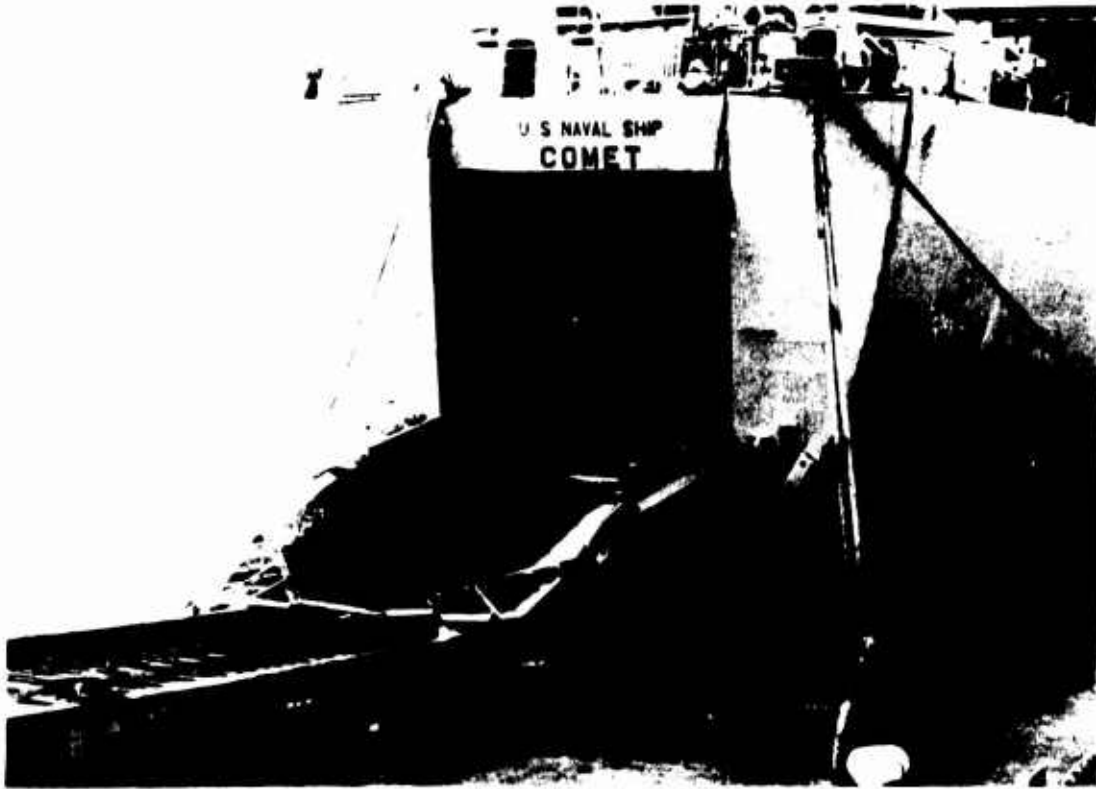
Figure 9-11. USNS Comet stern ramp.

b. The angle of the stern ramp proved too steep for RORO operations. Adjustments were made by placing the ship's side ramp on a wooden frame, and then lowering the stern ramp on top of the side ramp. This reduced the angle, but it was still fairly steep (fig 9-11). As soon as the upper tween deck was cleared, the aft side ramp was installed and utilized for the remainder of the RORO operations. (During REFORGER 76, the USNS Meteor was berthed at the same site, and its stern ramp was compatible with this RORO ramp; however, the USNS Comet's stern ramp is shorter by 15 feet 5 inches (4.7 meters); USNS Meteor's stern ramp is 44 feet 11 inches long (13.7 meters); and the USNS Comet's is 29 feet 6 inches long (9 meters), thus causing the steep ramp angle. The drafts of both ships is the same, and the water level is constant in the locked port of Ghent.)

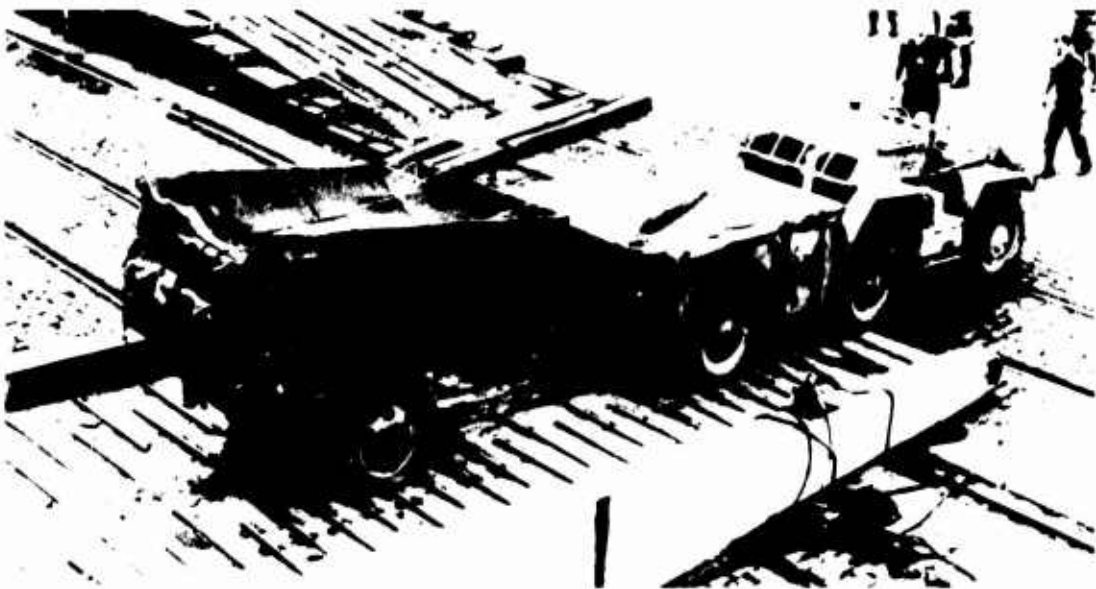
Figure 9-12. USNS Comet aft side ramp discharge.

c. The USNS Comet was discharged on an around-the-clock basis utilizing the stern ramp initially, and then the aft side ramp for RORO operations (fig 9-12). Shore cranes (fig 9-13) were used for lift-off of cargo from hatches 1 and 2, the main deck, and for the three helicopters from hatch number 4UT deck. Heavy lifts from the main deck were discharged by the aft jumbo boom of the USNS Comet. Drivers from the 4th Infantry Division (M) (-), scheduled to work in 12-hour shifts, actually worked from start to finish, shortening discharge time. Stevedores worked 8-hour shifts.

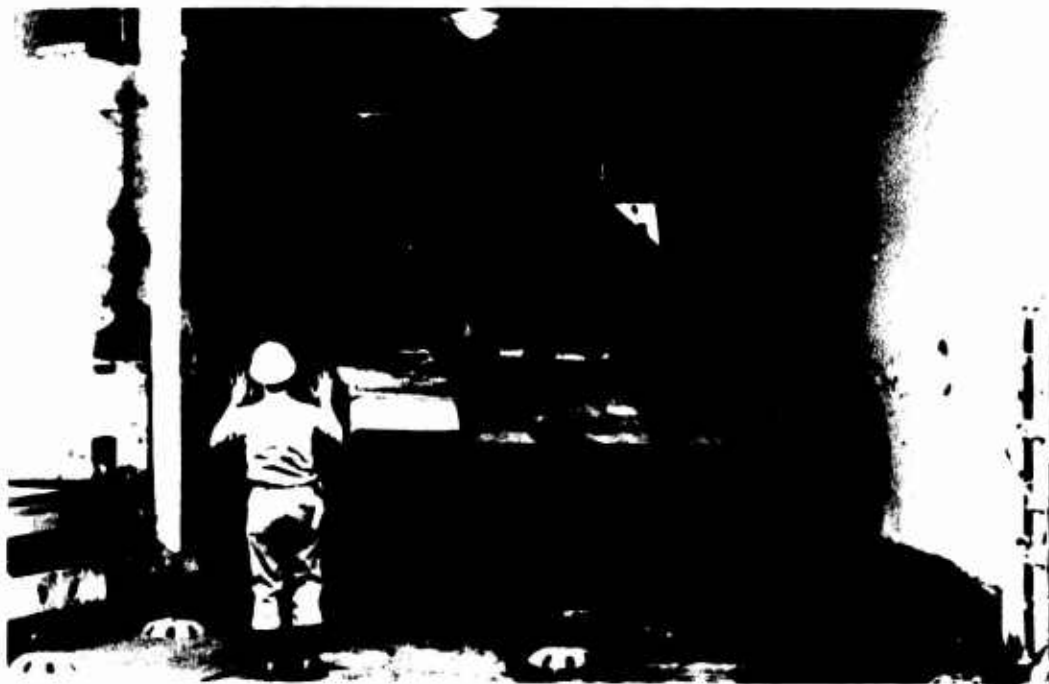
Figure 9-17. M60 tank on main deck drivethrough.

h. An attempt was made to roll off equipment stowed on the main deck (fig 9-17). M-88 tank recovery vehicles, however, were too long to negotiate the stern deck driveway and required lift off.

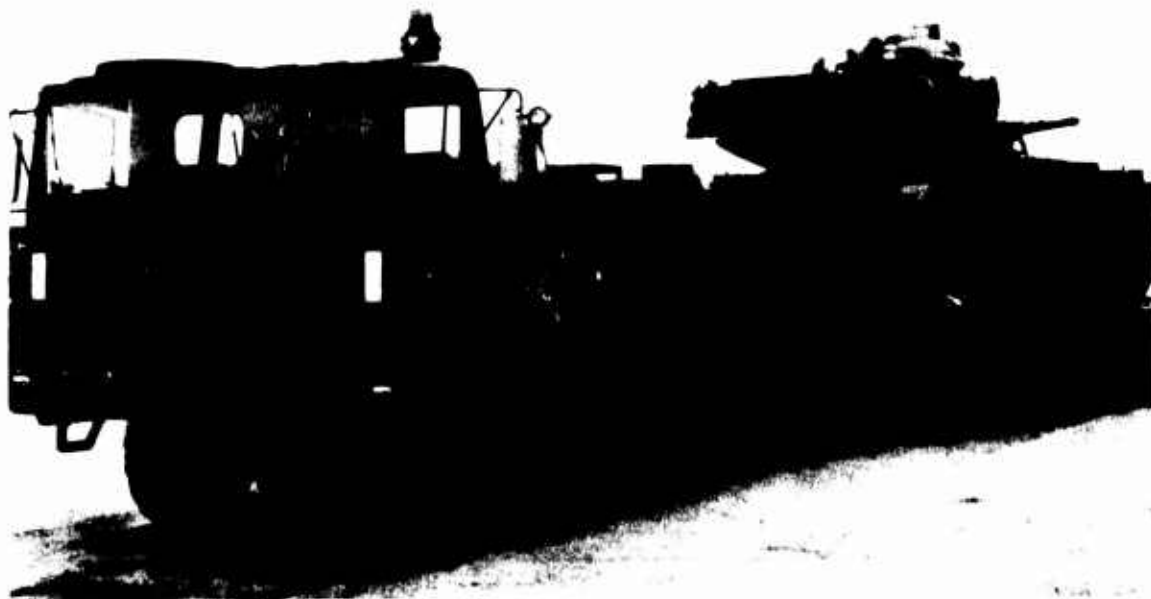
Figure 11-6. Highway delivery of equipment to Goliath Crane.

c. REFORGER equipment arrived at the barge loading sites by military vehicles (figs 11-5 and 11-6); by convoy (fig 11-7); and by helicopter fly-in (fig 11-8).

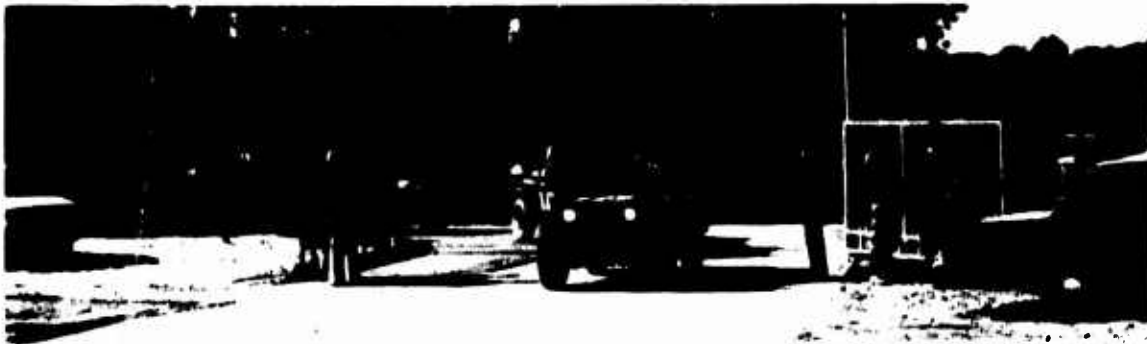
Figure 11-7. Highway convoy arriving at Rheinau.

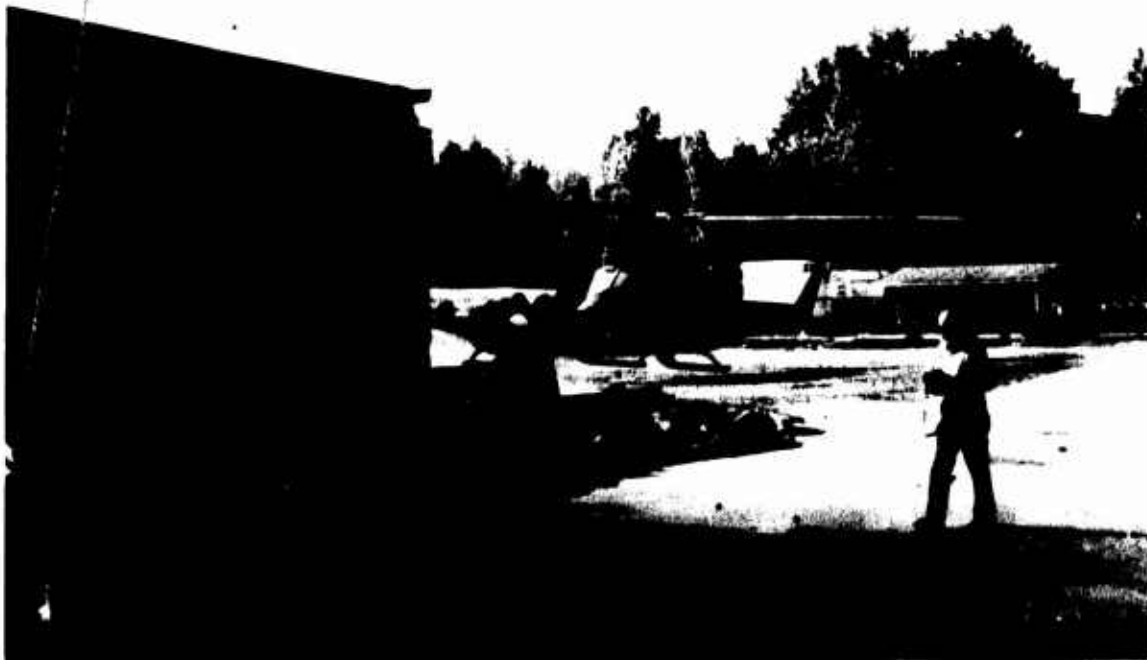
Figure 11-8. Helicopter arrival at Rheinau.
